**Phase 1  
Arborist Report  
Lee Property  
Holmes Point, Kirkland, WA**

**December 9<sup>th</sup>, 2014**

Date of Field Examination: December 4<sup>th</sup>, 2014

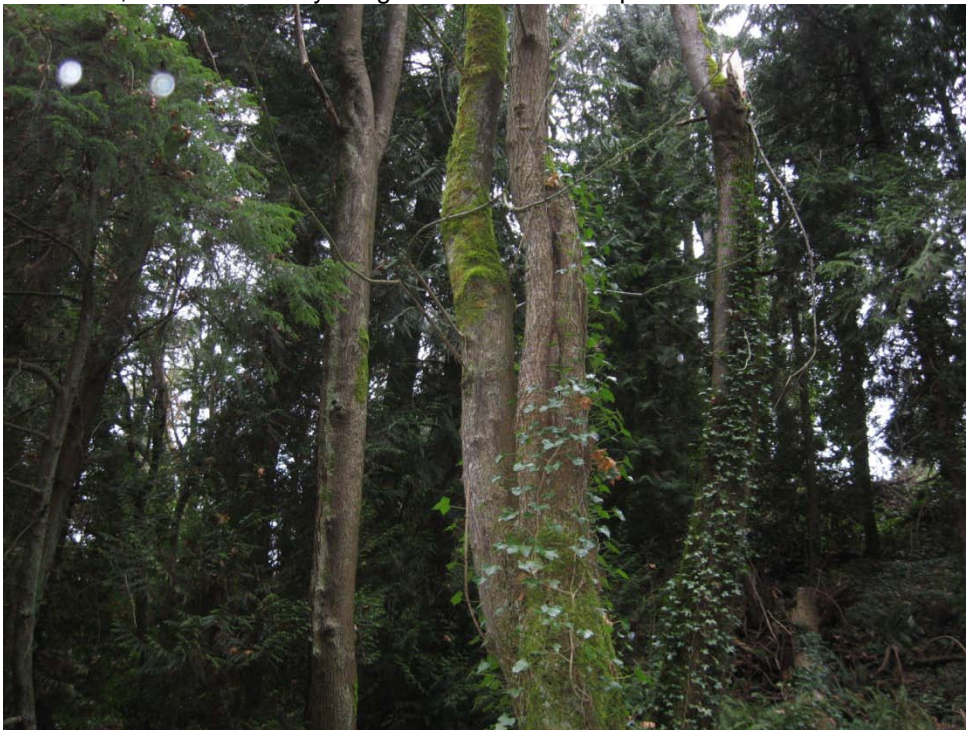
Tree #112, extensive decay in right stem of forked top

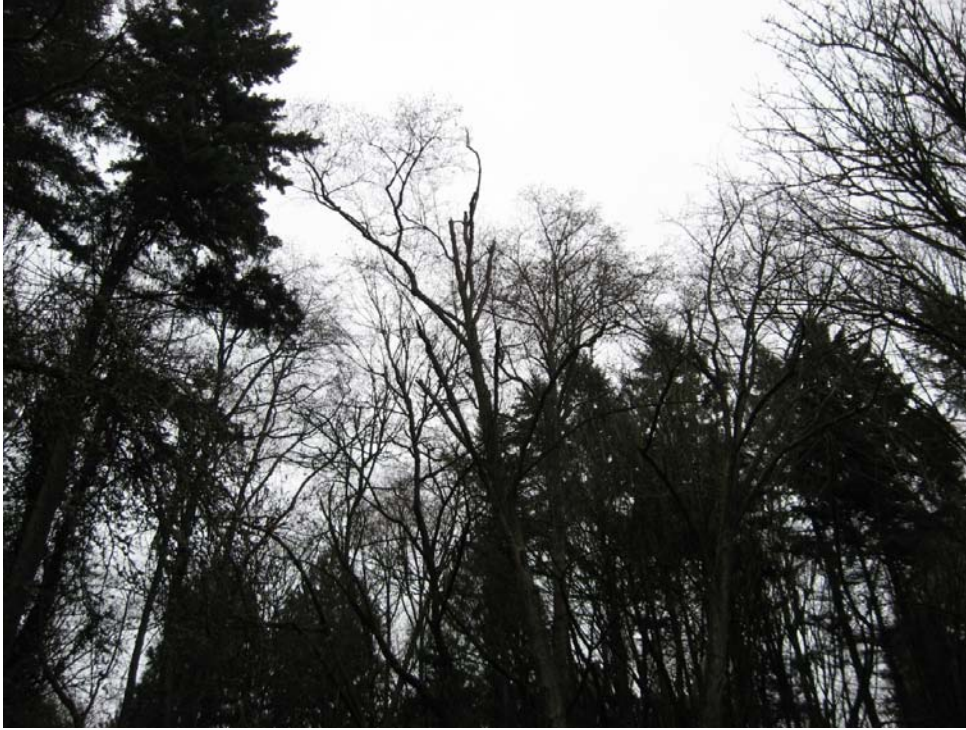
The red alder is over-mature. Many are considered non-viable due to age and present decline. Several have developed heavy leans toward the proposed driveway and are considered high risk.

Natural crown dieback of over-mature subject red alder

There are several over mature red alder trees that should be removed to abate the hazardous condition if work is initiated on the property. Many have heavy leans toward the proposed driveway. Alder is a fast-growing, short-lived pioneer species. These are at the end of their natural life spans and have begun to naturally decline. Alder dies back from the top down; shedding upper crown components as it naturally declines and deteriorates. Ivy in the upper crowns will contribute to premature failure. The alder that lean away from the proposed driveway can be retained since their failure will not hit an active target.

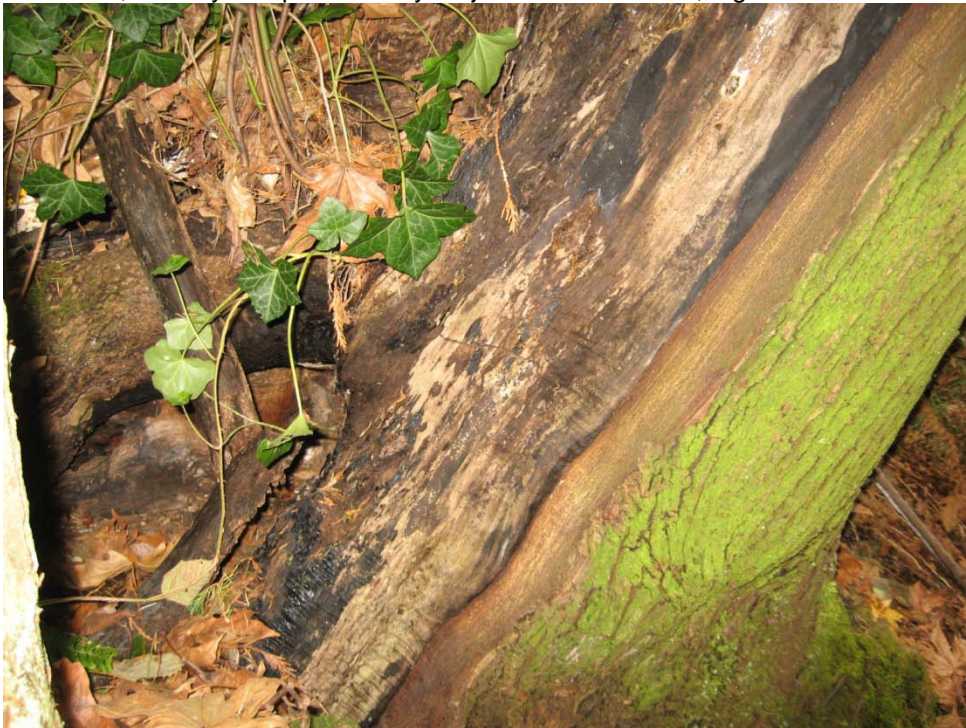
Tree #110, stability compromised by major soft rot infection, high-risk
